SEATTLE CITY LIGHT WORK ORDER #89-6
1989 MONITORING OF THE GEORGETOWN FLUME

RAVEN SERVICES CORPORATION
2200 SIXTH AVENUE, SUITE 519
SEATTLE, WASHINGTON 98121
(206) 443-1126; FAX (206) 443-1128

July 18, 1990

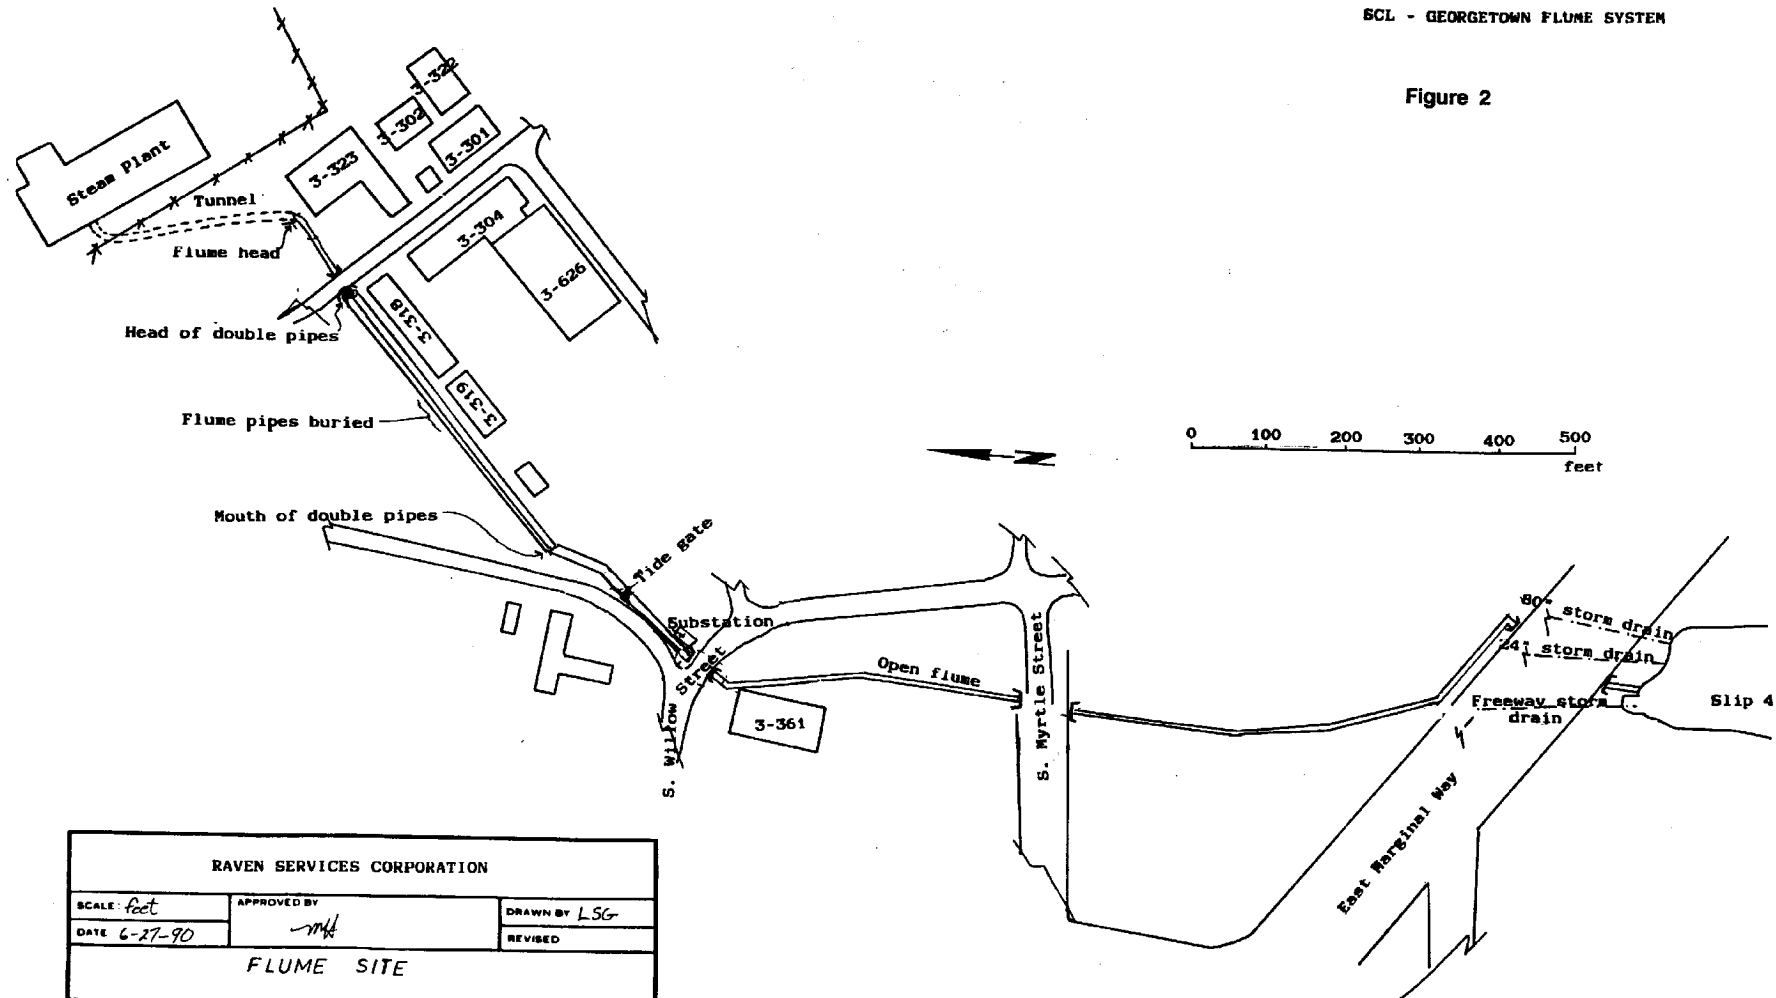
Figure 2

RAVEN SERVICES CORPORATION		
SCALE: <i>feet</i>	APPROVED BY: <i>[Signature]</i>	DRAWN BY: <i>LSG</i>
DATE: <i>6-27-90</i>		REVISED:
FLUME SITE		
SEATTLE CITY LIGHT		DRAWING NUMBER: <i>89-6-2</i>

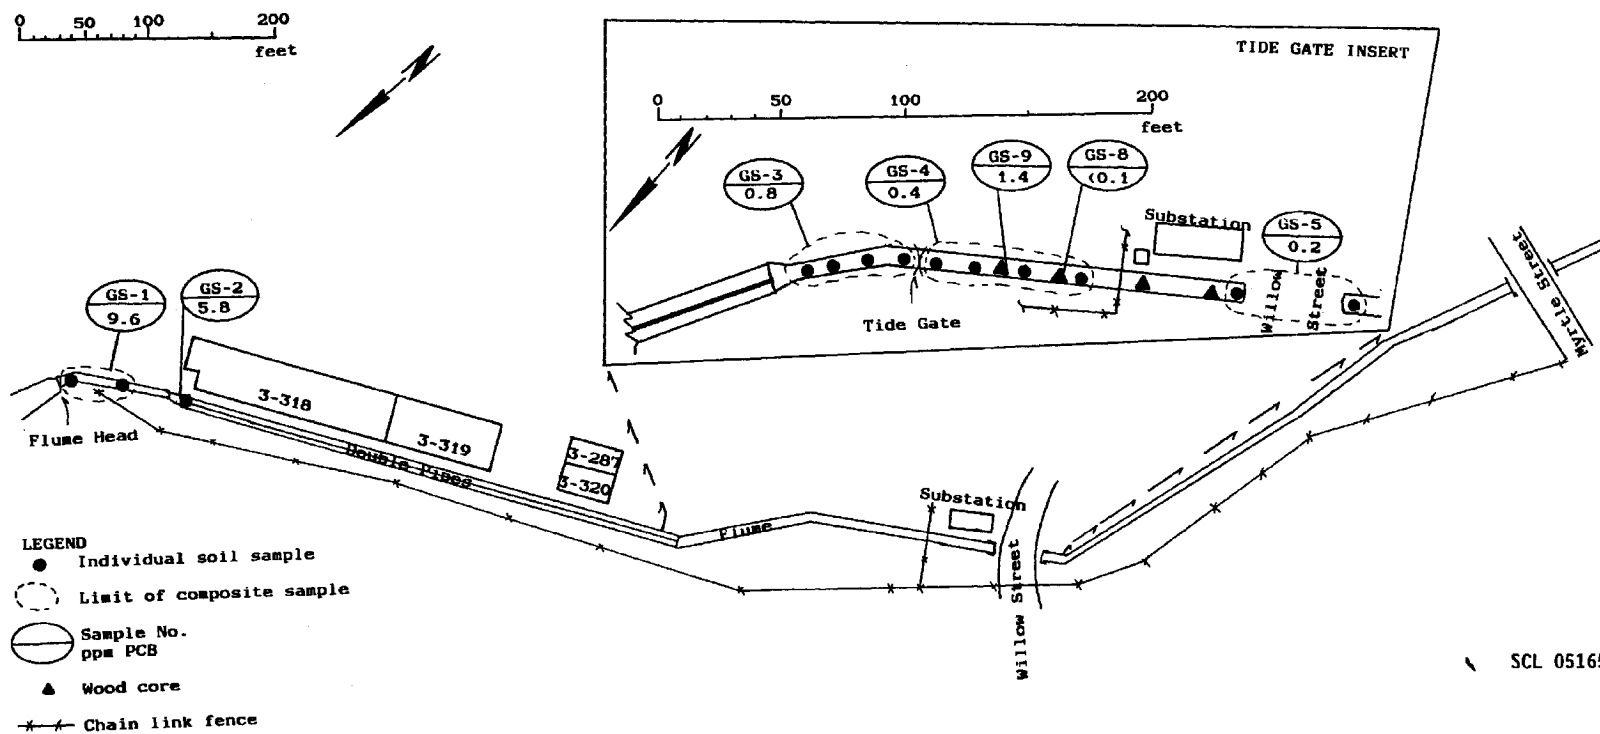
Figure 3

SCL GEORGETOWN FLUME SYSTEM
WINTER TESTING - 1989

Wood cores were specified for this project. Raven has devised a corer that can sample any of the wood floor locations. The corer consists of a steel punch, 5/8" in diameter and nine feet long. Threads at the bottom of the punch allowed the corer to be screwed out from the planks after it had been hammered in. A slot was cut 2-1/2 inches above the bottom of the core nose to facilitate sample removal. The device resembles a giant leather punch. Sampling locations are shown in the Figure.
